Vehicle Measurement Report

2024 Full-Size Pickup - Simulated Configuration

CASE  
SAMPLE-2026-001 - Simulated vehicle-reference review

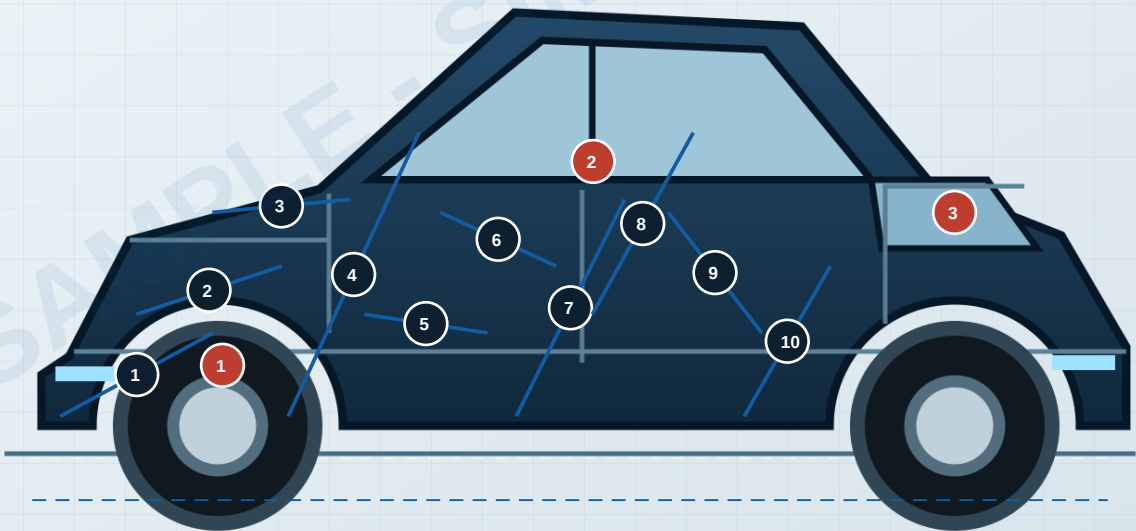
SIMULATED 3D VIEWER CAPTURE

Illustrative vehicle geometry - not an actual case or source vehicle

Figure 1 - User-selected 3D viewer capture; database snapshot is authoritative

10 saved measurements - 3 marked areas

Published wheelbase reference - 145 inches - verified 2026-08-10 16:15:00 UTC
